ALT-8000 Radio Altimeter, Part Number 87340; New Release of ALT-8000 Software Version 1.4.1 and Operations Manual

This information bulletin is to inform current users of the ALT-8000 of a new version of operational software and operations manual that is currently available for download.

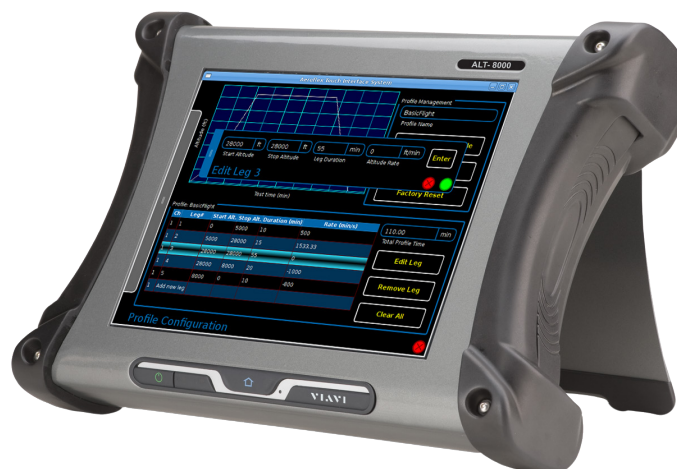
Note: Installation of F/W upgrade adds self-test capability to the menu selection. With some

1. test sets we have experienced occasional nuisance failures of the self-test for various tests due to slight variations in system hardware. If you do experience self-test failures with the updated F/W please contact customer service for further assistance. We are working to resolve these issues as soon as possible and your feedback is valuable in the resolution process.
